UTILIZING AUTOMATED MONITORING FOR THE FRANZEN RESERVOIR DAM SAFETY PROGRAM

Barry K. Myers, P.E.¹

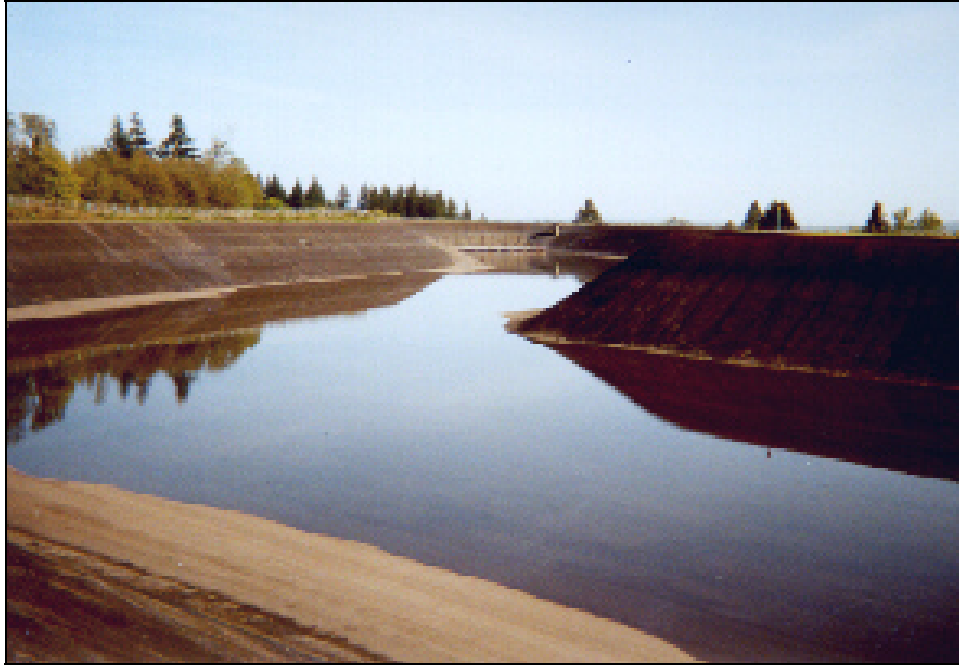
Photograph 1: Franzen Reservoir before the Rehabilitation Construction
(Standing at the northwest end and looking southeast).

In this regard the City of Salem, Oregon decided to improve their existing dam safety monitoring program for Franzen Reservoir. Franzen Reservoir is an uncovered, asphalt concrete lined impoundment, located above the town of Turner, Oregon. It provides storage for about 100-million gallons of potable water for the City of Salem. It was designed by the City of Salem and constructed in the 1950's by a combination of city forces and outside contractors. The reservoir was created by a combination of excavation and filling, with the excavated material used to form an embankment along the south side of the impoundment. The most likely mode of failure for the embankment was determined to be increased leakage through the asphalt liner leading to a piping and internal erosion failure. In fact, this failure mode was observed in 1979 along the outlet conduit for the overflow structure. Leakage was observed emerging from the downstream toe of the embankment and the reservoir was lowered to prevent further development of what was determined later to be piping erosion features.

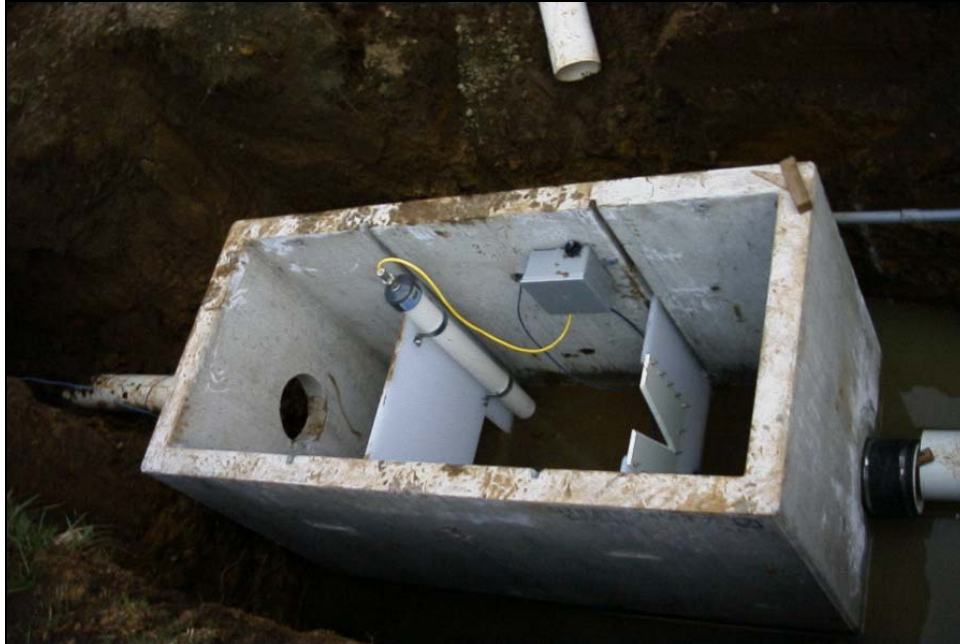
Photograph 2: Typical Weir Box for Monitoring Flows from the Seepage Collection Trenches (Weir 2 during installation including seepage collection piping entering and discharge piping exiting the weir box)

Flow from the seepage collection trenches was measured using weir boxes. The weir boxes included a 25-degree v-notch weir plate. The water level upstream of the weir plate was measured electronically in Weirs 1, 2, and 3 using a Geokon Model 4675LV vibrating wire water level sensor. A staff gauge was used to manually read the water level for Weir 4. The staff gauge was graduated in hundredths of a foot. Discharge from the weir boxes was collected in an outlet pipe, which conveyed the water to a culvert that discharged down gradient of the toe area. As with the piezometers, alarm threshold values were determined for each weir based on the expected seepage performance. These values were then adjusted based on the historical data that was collected.

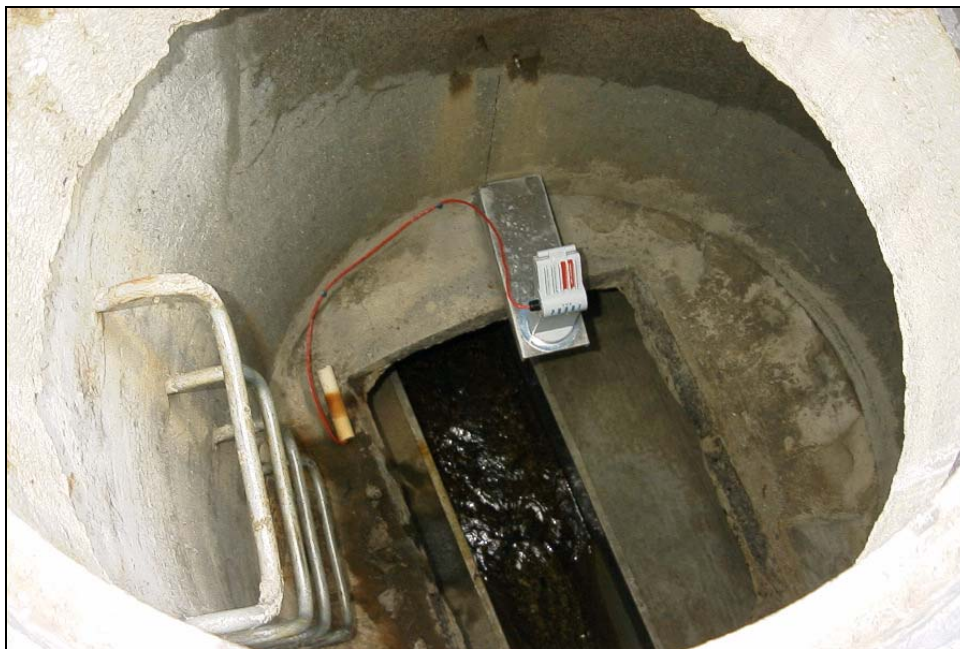
Photograph 3: Ultrasonic Level Sensor with Palmer-Bowlus Flume (Subdrain outlet manhole)

The existing water level sensor in the flume was replaced with a Milltronics Model PL-511 Loop Power ultrasonic level sensor which was connected to the ADAS. The ultrasonic sensor emits a sonic pulse at the water level within the flume and then measures the time for the pulse to travel to the water and back to the sensor. The measurement is then temperature-compensated and converted into distance for a current (mAmp) signal output that can be read by the ADAS. The sensor was mounted lower and in a different horizontal position than the previous SCADA sensor to provide more accurate readings of water level fluctuations in the flume. Readings were collected by the ADAS every 15 minutes and compared to an alarm threshold value. Water stage and flow data was also logged once per day for historical evaluation purposes.

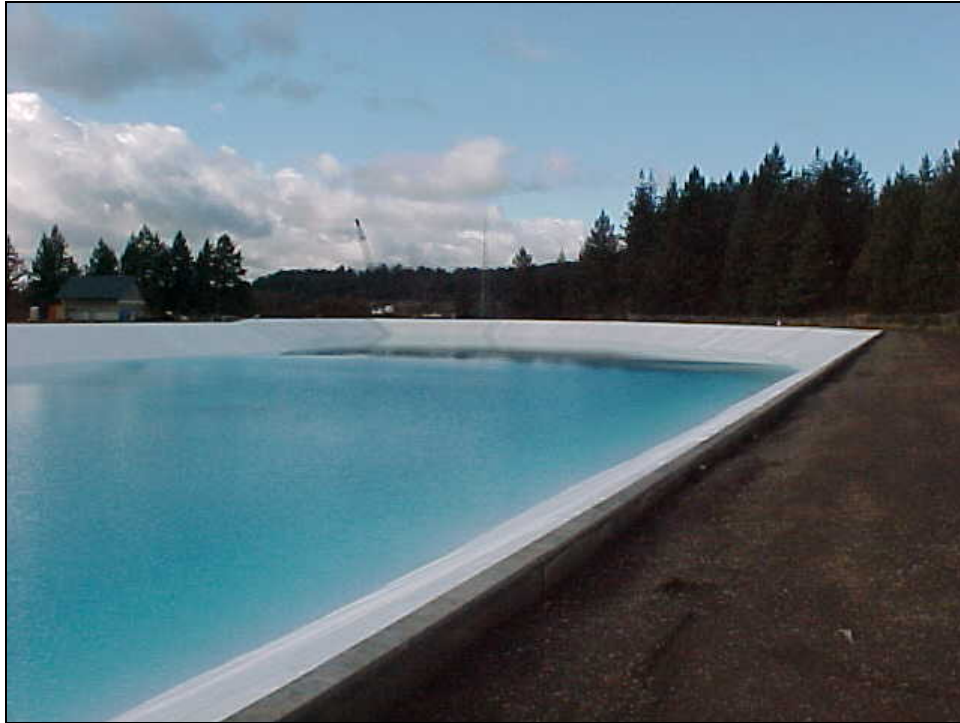
Photograph 4: Franzen Reservoir after the Rehabilitation Construction
(Standing on the southeast cut slope looking northwest)
